## Inspection Report

**Madison County/ Jack Hobbs**

110 N Main St  
Madison VA 22727

**Burgess Inspections Inc.**

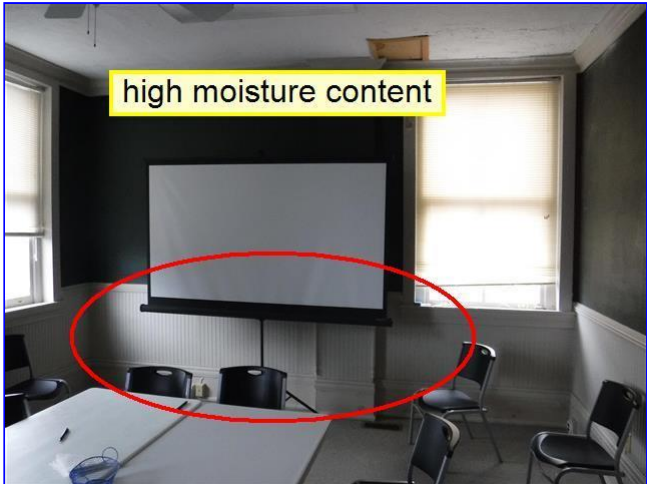
3.1 Item 5(Picture)

(2) The right side of the building (conference room) has a high level of moisture in the wall. Recommend evaluation and repair by a qualified contractor in this field.

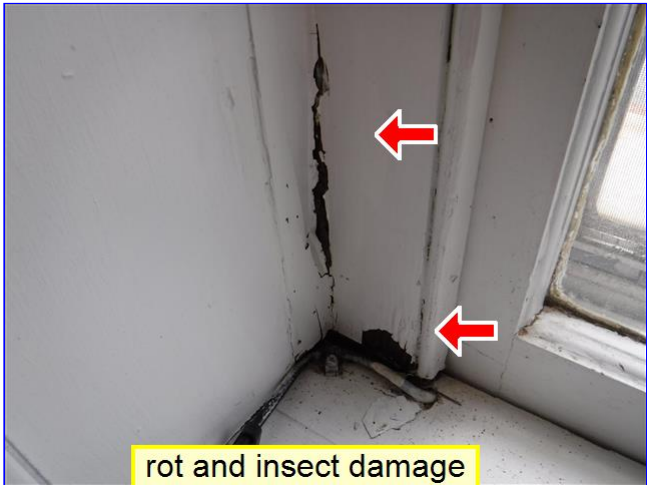
3.1 Item 7(Picture)

(3) The main floor has two windows at the back with rot and past insect damage. Recommend evaluation and repair if needed by a qualified contractor in this field.

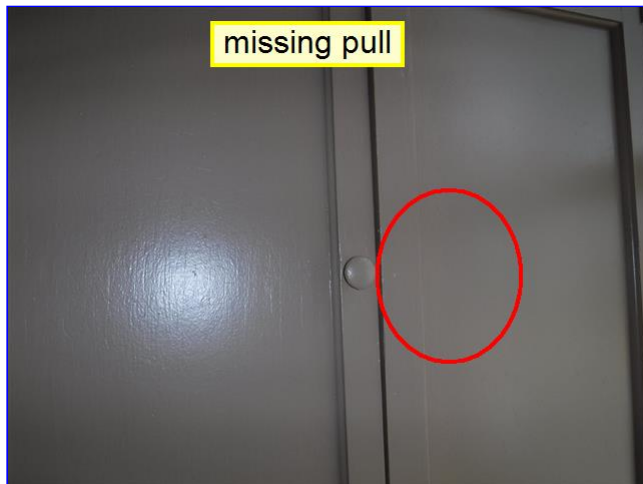
3.4 Item 1(Picture)

One kitchen cabinet is missing a pull. Recommend repair if needed by a qualified contractor in this field.

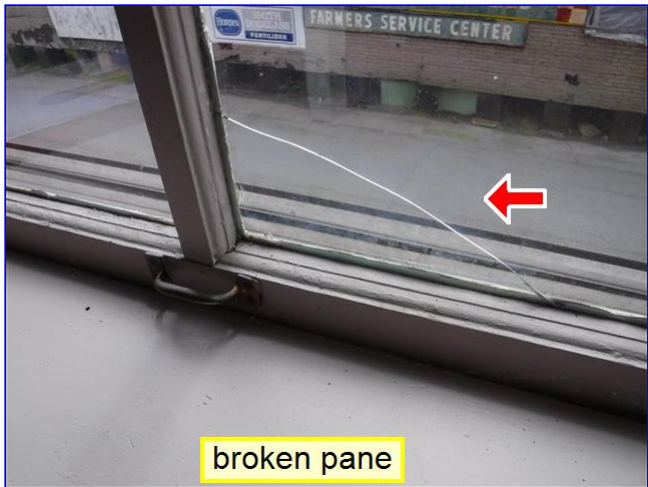
3.6 Item 1(Picture)

(1) There were three broken window panes noted. These are located in the upstairs back room. Recommend evaluation and needed by a qualified contractor in this field.

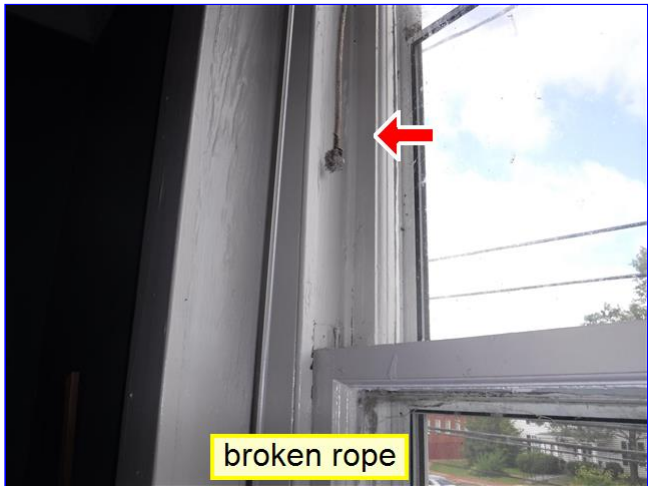
3.6 Item 4(Picture)

(2) The vast majority of the windows in the building would not open. Many had broken pulley ropes and missing locks. Recommend evaluation and repair by a qualified contractor in this field.

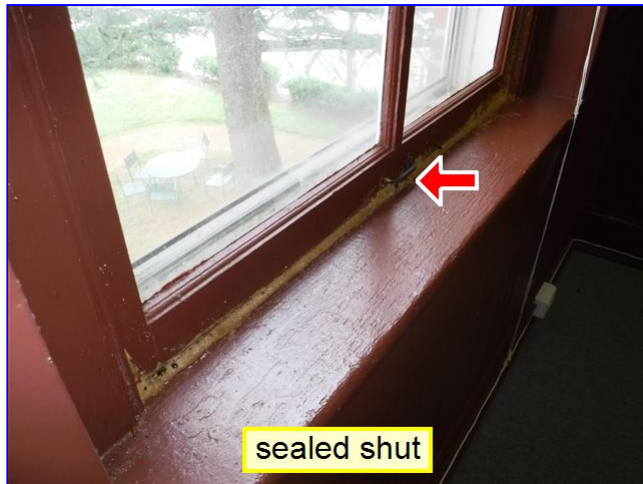
3.6 Item 7(Picture)

(3) The upstairs side room window has been sealed shut. Recommend evaluation and repair by a qualified contractor in this field.

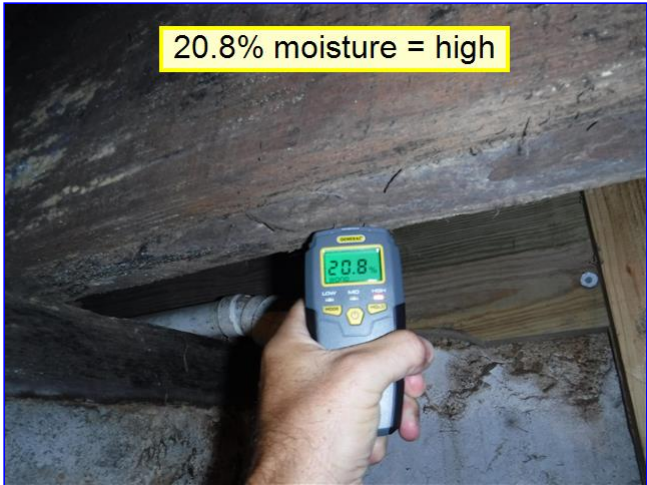
4.0 Item 1(Picture)

(1) There are active leaks in both basement walls. These leaks have standing water on the floors and there is mold or microbial growth present along with high levels of moisture in the joists, girders and walls. Recommend repair by a qualified contractor in this field..

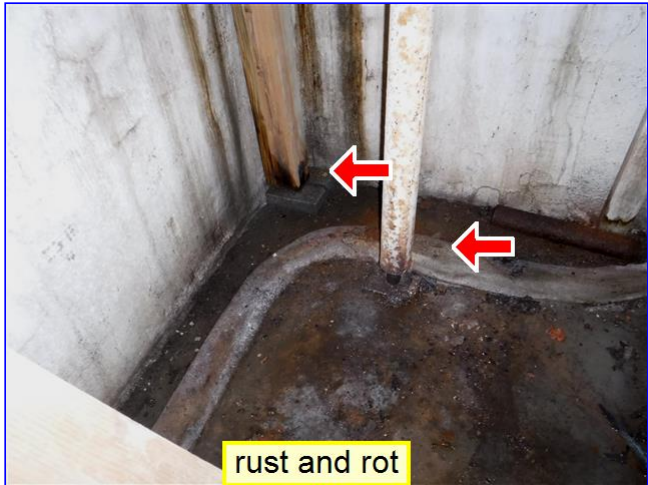
4.0 Item 6(Picture)

(2) There are many added wood and metal supports in the basements. These are rusting and rotted at the base. Recommend repair by a qualified contractor in this field.

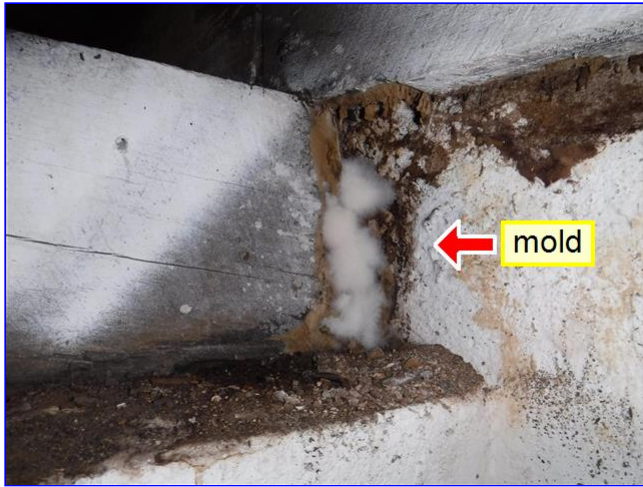
4.0 Item 11(Picture)

(3) Mold growing in the basements. Recommend repair by a qualified contractor in this field.

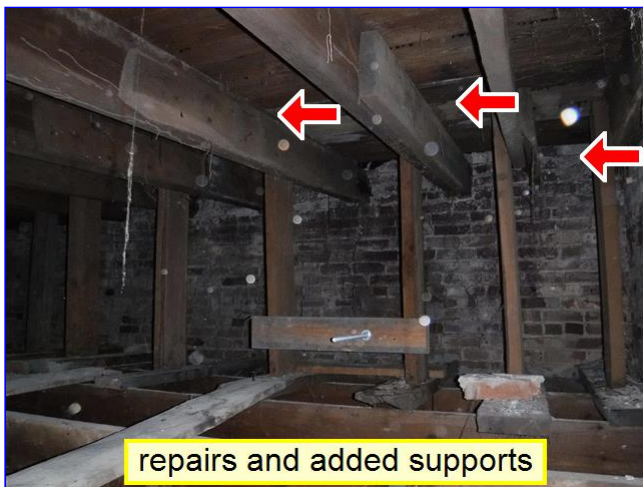
4.7 Item 1(Picture)

(1) There is evidence of repairs and water intrusion in the attic space. This appears to be isolated, but it is beyond the scope of this inspection to determine the exact cause. Recommend evaluation and repair by a qualified contractor in this field.

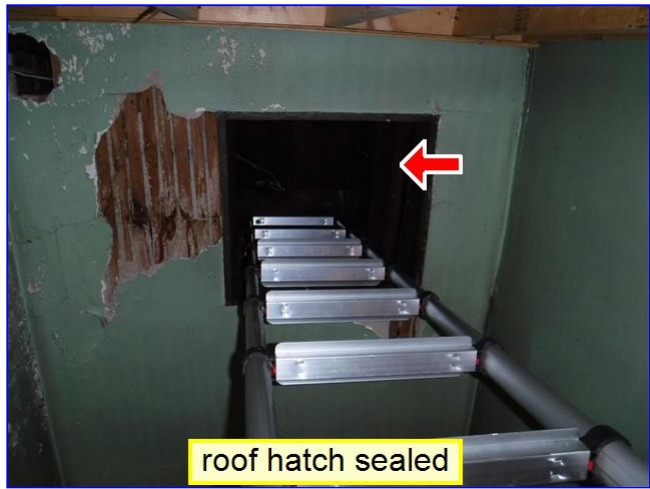
4.7 Item 3(Picture)

(2) The hatch to the roof has been covered over and sealed. I could not get it open and access the roof. Recommend repair by a qualified contractor in this field.

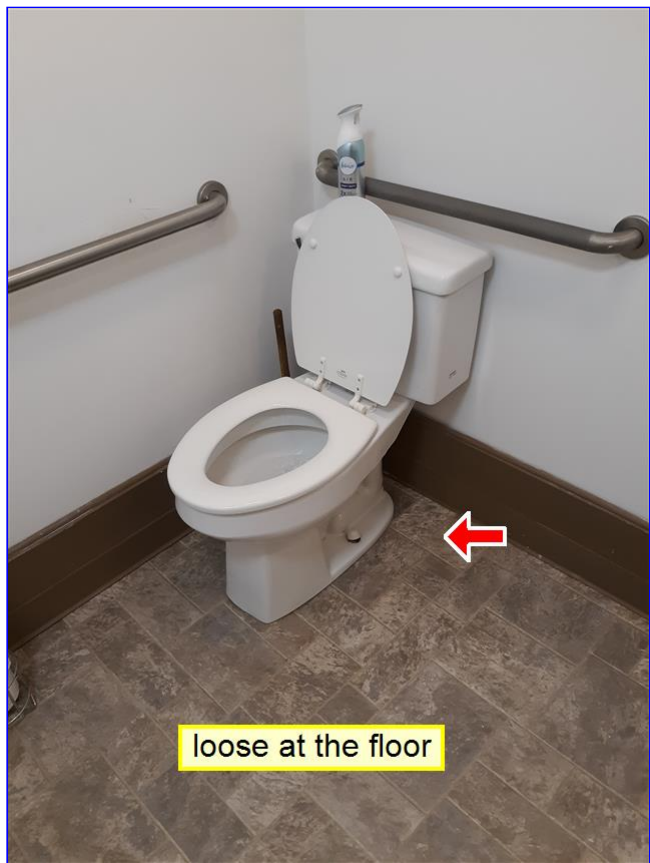
5.1 Item 1(Picture)

(1) The toilet is loose at the floor. Repairs may involve re-setting the toilet on a new wax seal. I recommend a qualified licensed plumber repair or correct as needed.

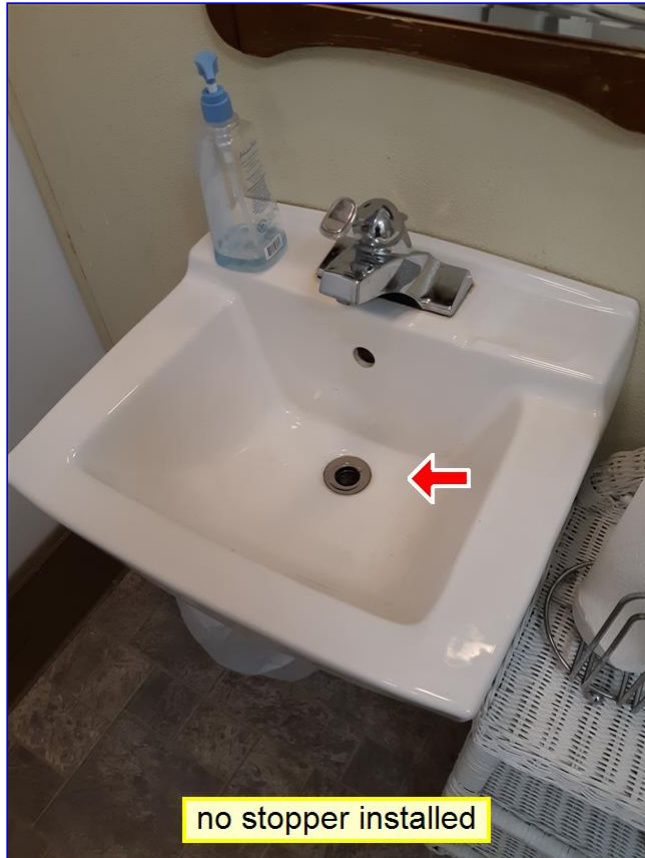
5.1 Item 2(Picture)

(2) The bathroom sink is missing a stopper. Recommend repair by a licensed plumber.

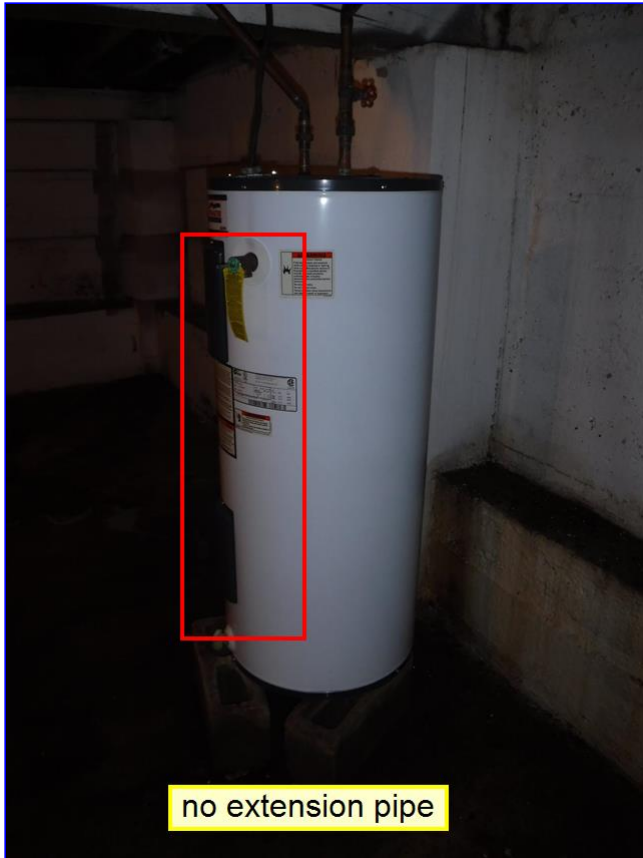
5.2 Item 1(Picture)

(1) There was no pressure relief valve extension. This should be installed by a licensed plumber.

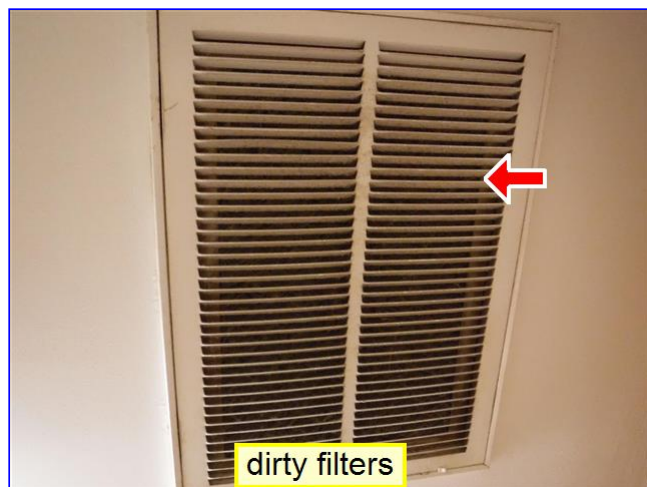
7.4 Item 1(Picture)

The filters were dirty. Recommend repair by a qualified person in this field.
